VESSEL: APJ ANGAD 2

Mitsui MAN B&W 6S60MC (Mark VI)

MAIN ENGINE CONDITION SURVEY

DATE FROM – 15/02/2018 TO - 16/02/2018

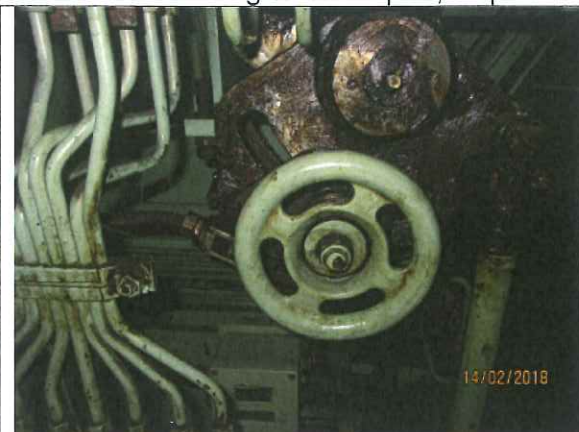
We have checked fuel regulating linkage system and found that the Local and Remote select clutch (local stand) was loosen (locking device released) and big lost motion in between governor and fuel pump rack (index). That means the clutch was not engaged with governor properly.

Select clutch for Remote or Local control on Local control stand.

Recommendation	<ol style="list-style-type: none">1. Need to lub. oil fill in to spring air chamber for lubrication and smooth movement the exhaust valve open and close when reconditioning the exhaust valve.2. When emergency stand operation, must confirm the changeover clutch selection position and secure the locking device properly.3. Turbocharger overhaul to be done with the makers approved workshop
Material Supplied	As per owners confirmation order of turbocharger spares has been placed with the makers

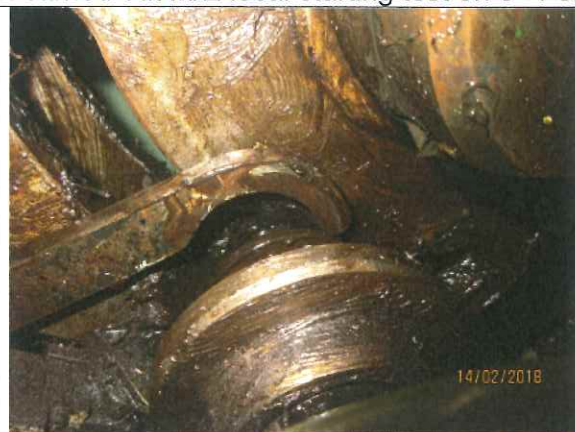
When governor stop position (0) but showed fuel pump index 20/19/19/22/21/21.

Released locking device and loose clutch (not tighten properly)

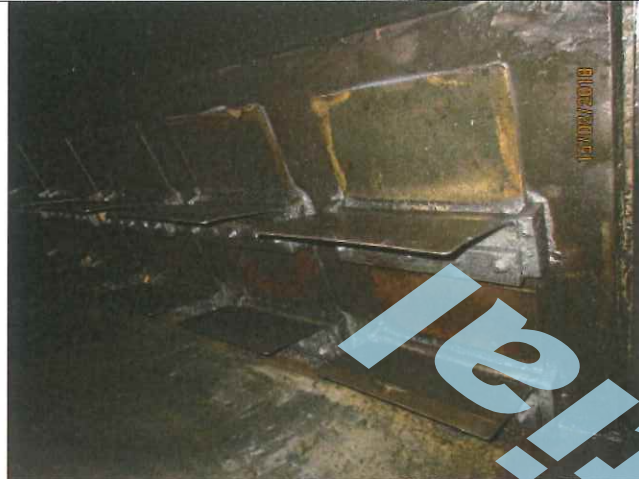
We have inspected scavenge air receiver, as a result of inspection all the flaps and non-return valves were intact condition.

Non-return valve on scavenge manifold (intact)

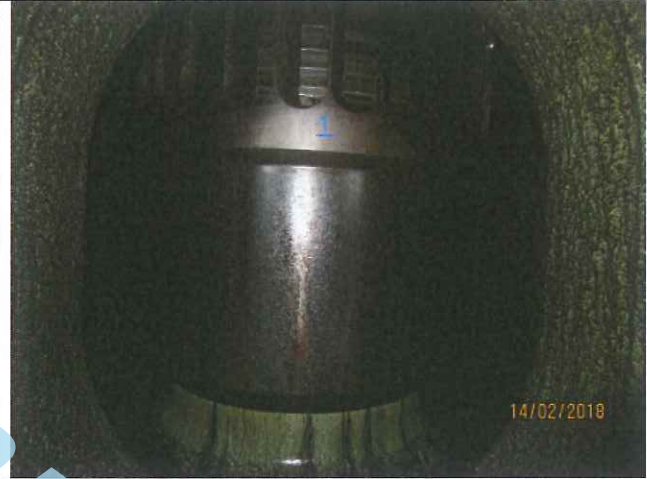
Carbone deposit on under cyl' liner (Acceptable)

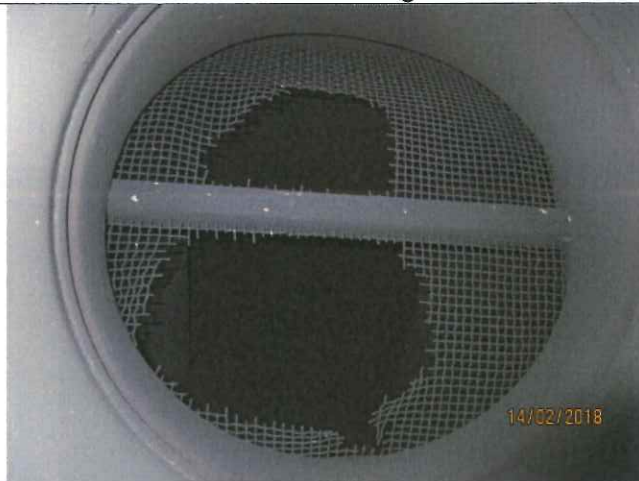
We have inspected gas receiver and found that partly broken the wire mesh in way of T/C gas inlet, might be the broken pieces of wire meshes go in to T/C and then it was made damage turbine blades and nozzle ring.

T/C gas inlet, mesh broken.

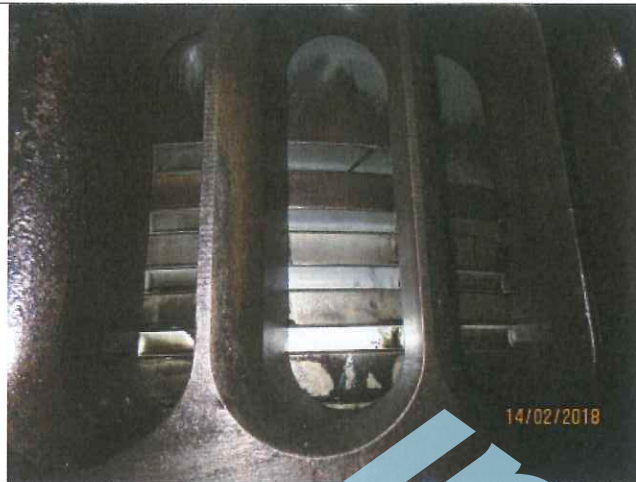
No.1

We have checked piston ring, piston crown condition and measured clearance of piston top ring. As a result of inspection, all the piston rings are no broken, freely move, good surface. Measured clearance for piston top ring and found all the rings are within acceptable clearance.

Cyl No	1	2	3	4	5	6
Clearance	0.45	0.45	0.50	0.50	0.55	0.60

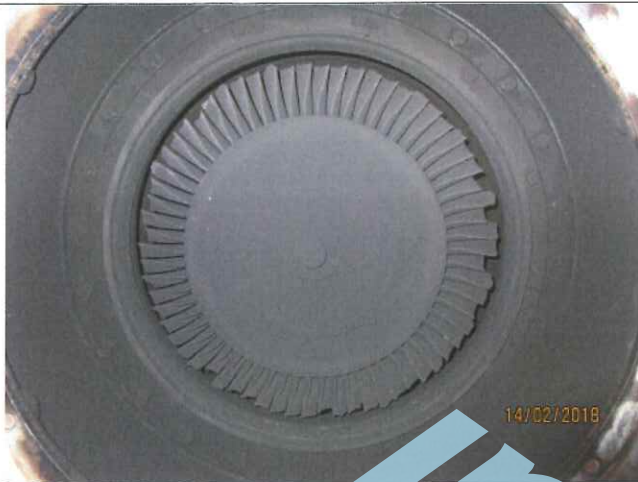
After overhauled and found that damage parts as below.
Turbine blades, nozzle ring. (Dalwin Marine attending the repairs)

T/C turbine blades (damaged)

Root cause of the problem is excessive temperature or overheated exhaust gases:

- The turbine wheel has become eroded
- The turbine inlet wall is cracked
- There are spots of burnt oil on the turbine shaft
- The bearing housing oil drain cavity is blocked

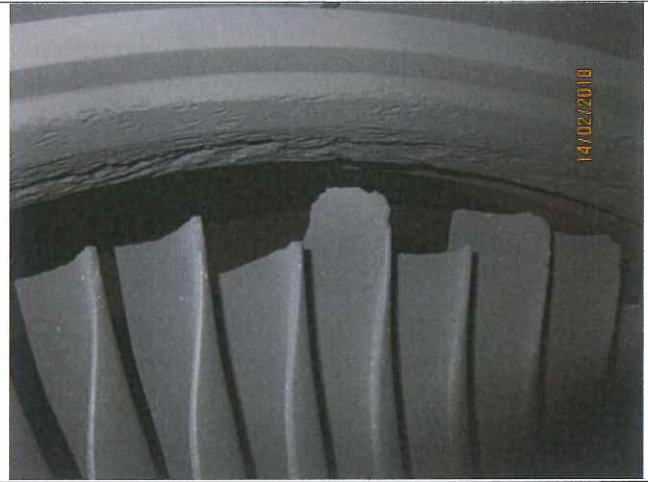
T/C Turbine blades damaged (Details)

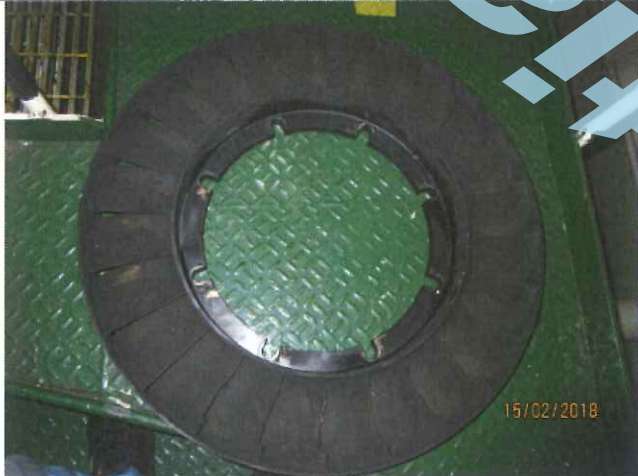
Nozzle ring (damaged)

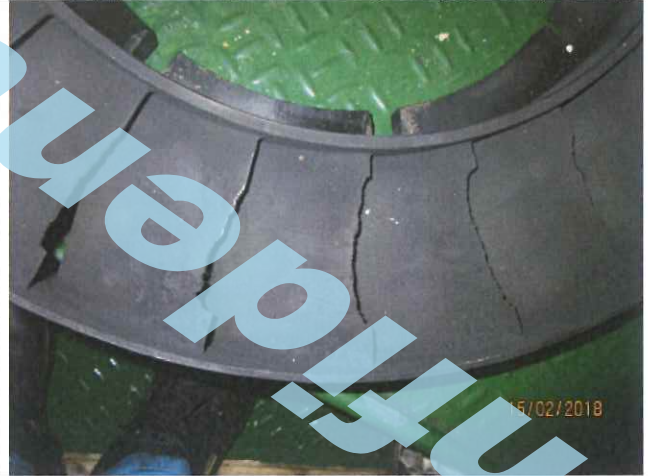
Nozzle ring (Details)

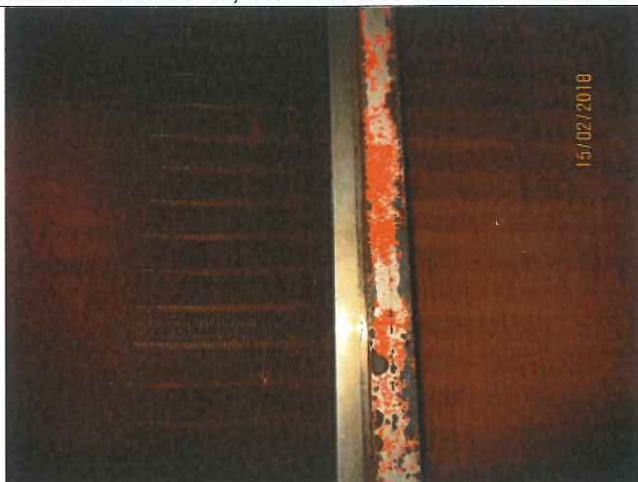
Air cooler element

Inspection of the air cooler element, the element was acceptable condition but not sure the internal condition, carried out chemical and water spray cleaning done.

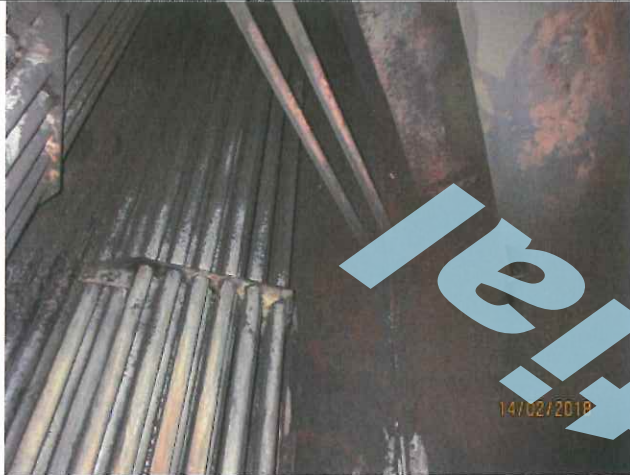
As the result of internal inspection, we found carbon deposit but still acceptable conditions. carried out cleaning done.

Inside economizer (P-side)

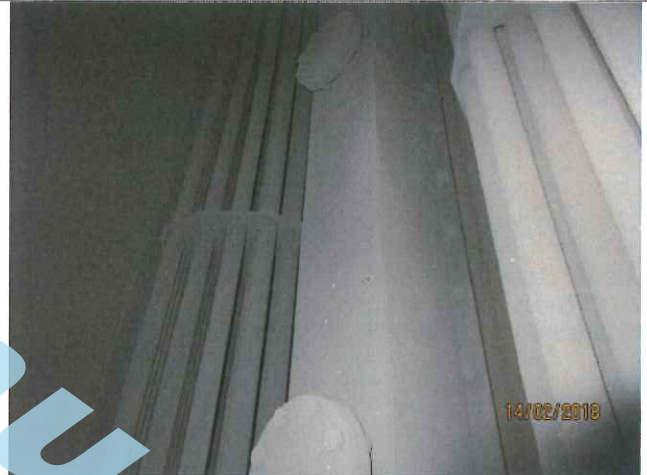
Inside economizer (S-side)

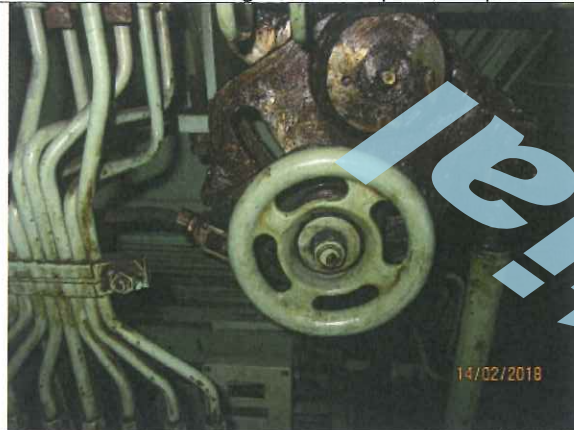
We have checked fuel regulating linkage system and found that the Local and Remote select clutch (local stand) was loosen (locking device released) and big lost motion in between governor and fuel pump rack (index). That means the clutch was not engaged with governor properly.

Select clutch for Remote or Local control on Local control stand.

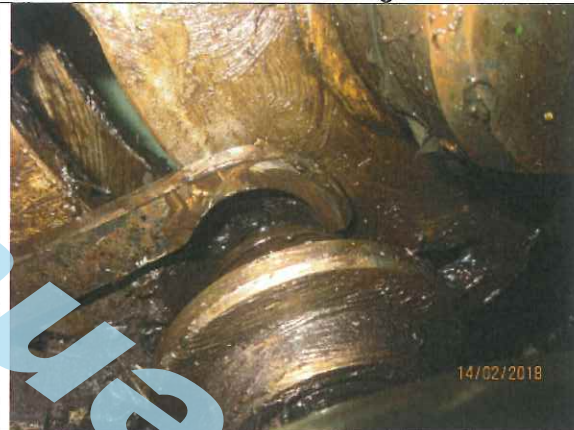
When governor stop position (0) but showed fuel pump index 20/19/19/22/21/21.

Released locking device and loose clutch (not tighten properly)
