## ALPHA LUBRICATOR OVERHAULING REPORT

JOB NO	: 1604079	TYPE	: KAWASAKI B&W 7S80MC-C
CUSTOMER	: _____	DATE INSPECTION	: 6/3/2016
VESSEL	: _____	CUSTOMER W/O NO	: 2090-E-16-804 (91022230)
PREPARE BY	: Maung	CUSTOMER REQUIRE	: <input type="checkbox"/> Normal Time
DESCRIPTION	: 14 nos of Alpha Lubricator Cylinder overhauling		: <input checked="" type="checkbox"/> Urgent Time

### Overhaul of Alpha Lubricator Assy 14-units

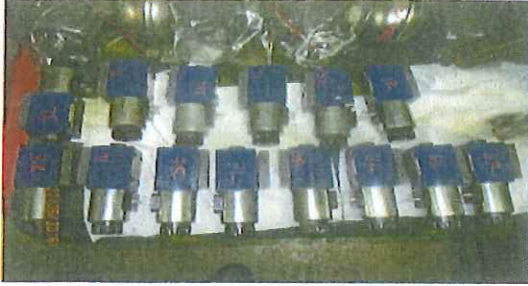
Remove and visual inspect the

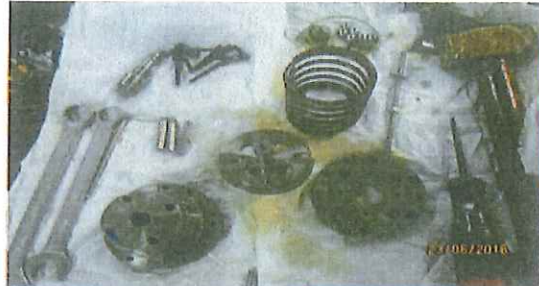
Dismantling the Lubricator Units

- Dismantle
- Cleaning and inspection.
- Assemble back with new spare parts.

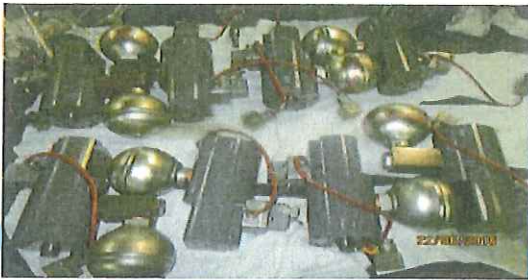
After Re-assemble the Cylinder

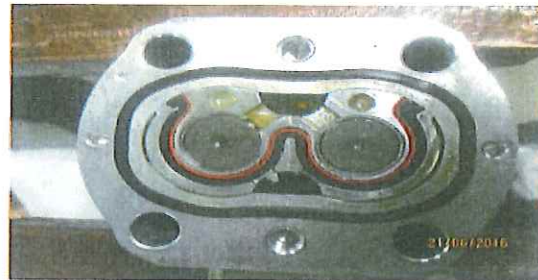
Renew Seals for Gear Pumps

- Gear pump
- Dismantle
- Cleaning and inspection
- Assemble with new spare parts

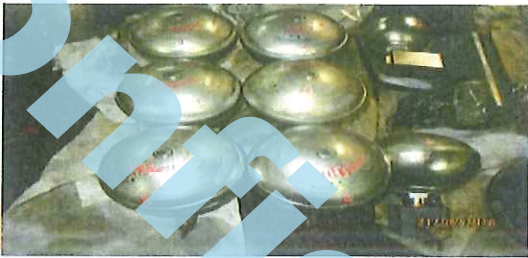
Re-new all Accumulator

- Dismantle
- Assemble with new accumulator

- Dismantle
  - Assemble with new accumulator
- (New accumulator is not necessary recharging work and the life time is five years.)

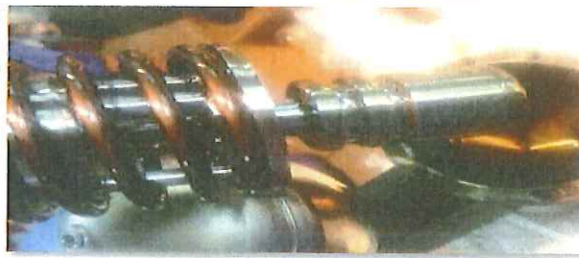
Condition of the Piston

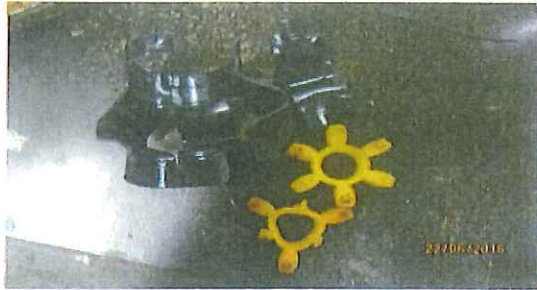
Found 1 Spider Coupling broken

- Motors were overhauled by vessel engineer before docking
- Spider Coupling Housing dismantled and renew Spider

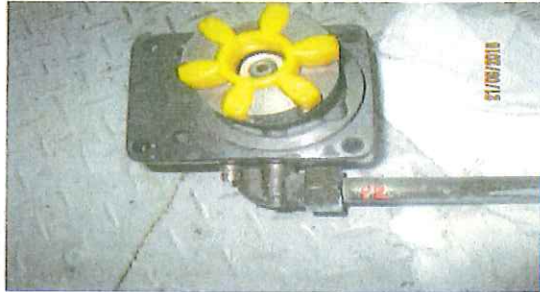
After Re-new the Spider

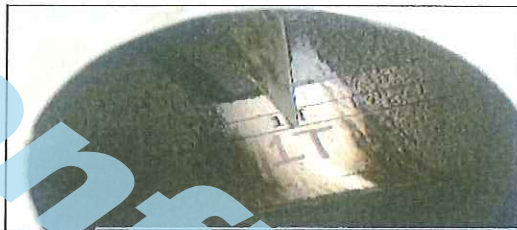
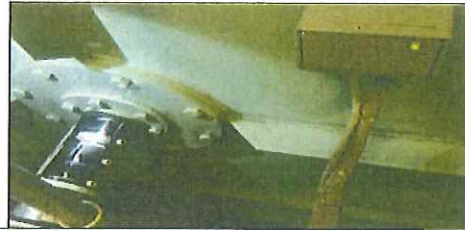
it was tested and confirmed LCD (D88/D89) were light on at the top dead of the No,1 piston.  
It is in normal condition

Check the Rotary Encoder - Mounting condition and coupling condition

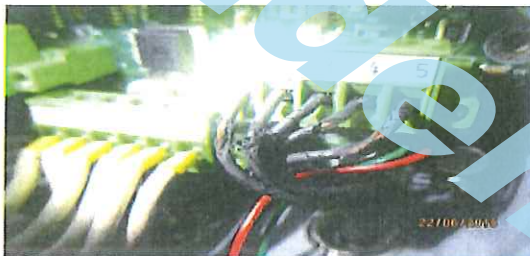
Found wires in Intermediate box are

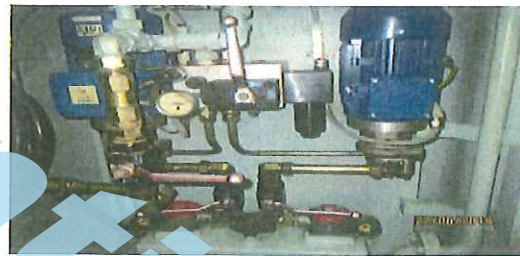
Motor are overhaul by vessel engineer
