# MERCANTILE MARITIME SOLUTIONS PTE LTD

## FUEL PUMP INSPECTION REPORT

JOB NO : 1604078 TYPE : KAWASAKI B&W 7S80MC-C  
 CUSTOMER : \_\_\_\_\_ DATE INSPECTION : 6/3/2016  
 VESSEL : \_\_\_\_\_ CUSTOMER W/O NO : 2090-E-16-804 (91022230)  
 PREPARE BY : Maung CUSTOMER REQUIRE :  Normal Time  
 DESCRIPTION : 7 nos M/E Fuel Pumps  Urgent Time  
 Remarks : \_\_\_\_\_

FUEL PUMP CALIBRATION / INSPECTION REPORT

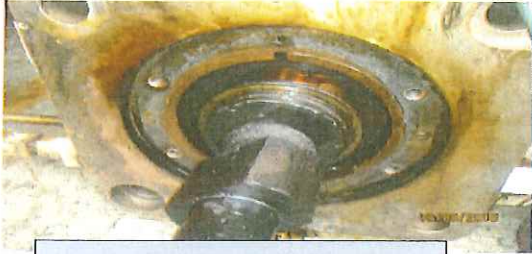
Dismantling of Fuel Pumps

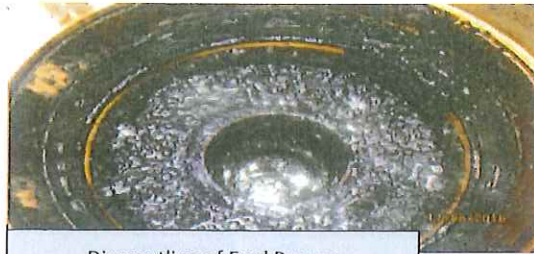
Dismantling of Fuel Pumps  
Found Oil Sludge on Barrel top side

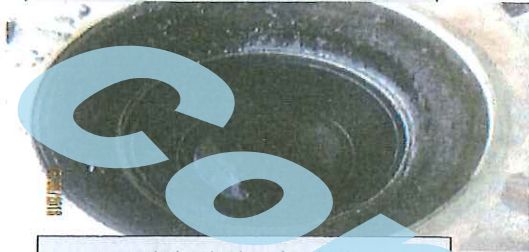
Found Shock Absorber leakage

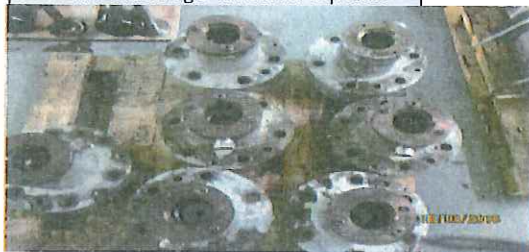
After cleaning Top Covers

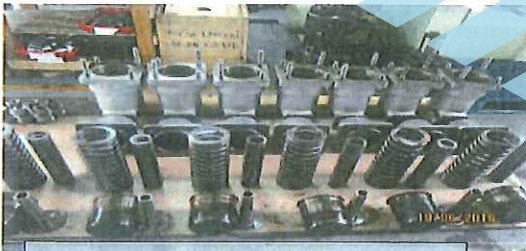
After cleaning the Shock absorber

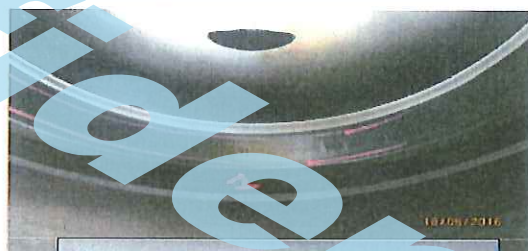
Found all Pump Body Barrel Seal sitting area

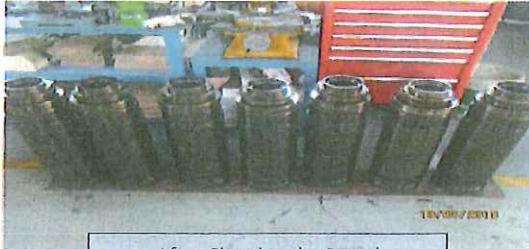
After Cleaning the Barrel

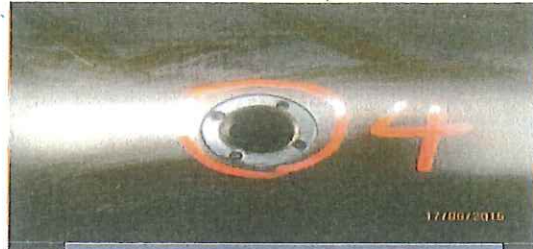
Remark : Total 7 nos plunger & barrel carried out inspection & calibration. Found No 4 Throttle plug missing

Found #4 Barrel Orifit missing

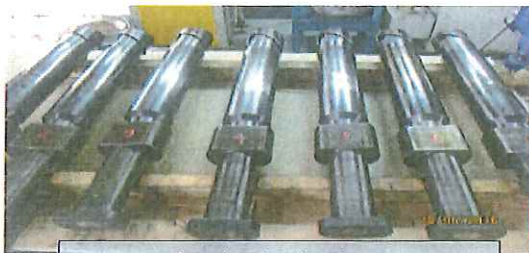
After cleaning the Plunger

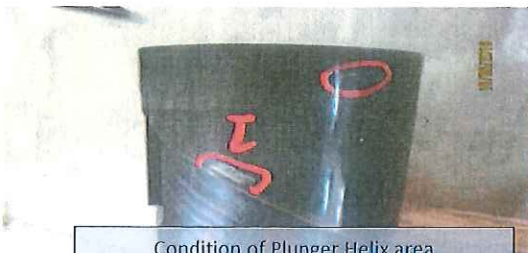
Condition of Plunger Helix area

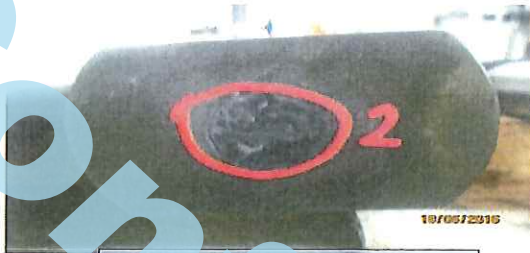
Found #2 Plunger Nob hit marks

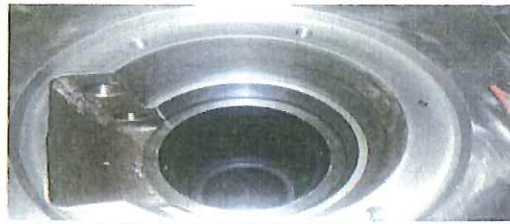
After cleaning the Pump Body

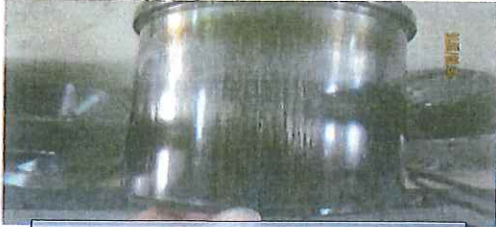
Found Shock Absorber Piston scratch marks

After Polish the Shock Absorber Piston

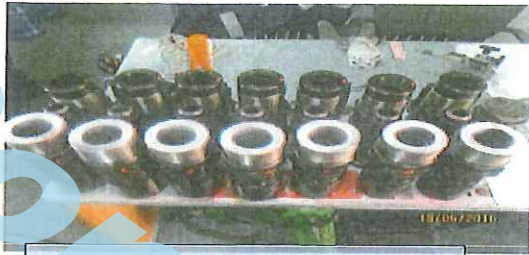
Crack check for Suction Valve

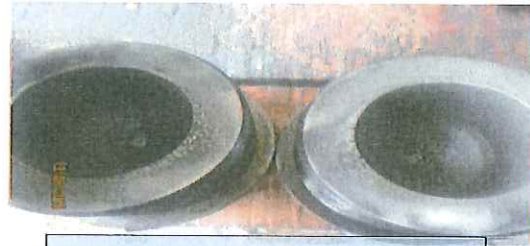
Found all Plung Screw small cavitation, polish

- a) Plug Screw all Grind to remove cavitation and Re-use (Recommend to re-new on Next Docking)
- b) All Timing Guide (433A 12) contact surface scratch marks (polished and Re-used)
- c) # 1, 2 Shock Absorber Spring (External & Internal) Re-new
- d) #1 Shock Absorber Spring Guide Re-New
- e) All Suction Valve Spring replaced with NEW
- f) No. 4 Unit installed with NEW PLUNGER BARREL

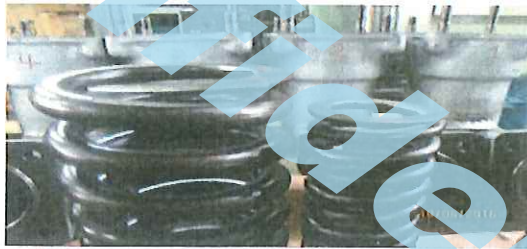
#1 & 2 Spring (External & Internal) re-new

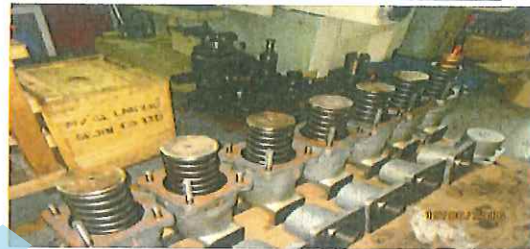
Re-assemble of Shock Absorber

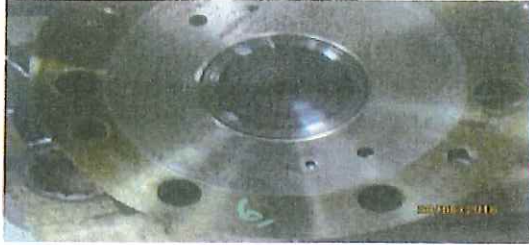
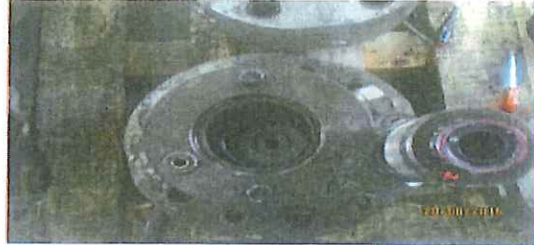
Suction valve / Puncture Valve landing surface machine grind & confirm contact

<input checked="" type="checkbox"/>	Suction casing internal seat to be machined ground	Qty <u>7</u> nos
<input checked="" type="checkbox"/>	Suction valve lid to be machined grind	Qty <u>7</u> nos
<input checked="" type="checkbox"/>	Puncture valve internal seat to be machined ground	Qty <u>7</u> nos
<input checked="" type="checkbox"/>	Puncture valve lid to be machined ground	Qty <u>7</u> nos
<input type="checkbox"/>	Top Cover Landing surface of Puncture Valve to be machined	Qty <u>      </u> nos
<input type="checkbox"/>	Top Cover Landing surface of Suction Valve to be machined	Qty <u>-</u> nos

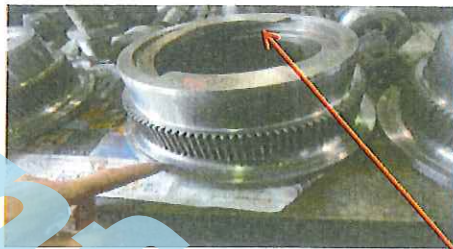
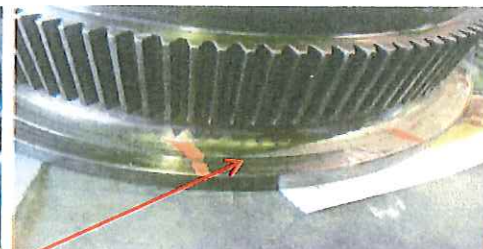
Found all Timing Guide contact surface worn down
