VESSEL: APJ ANGAD 2

Mitsui MAN B&W 6S60MC (Mark VI)

MAIN ENGINE CONDITION SURVEY

DATE FROM – 15/02/2018 TO - 16/02/2018

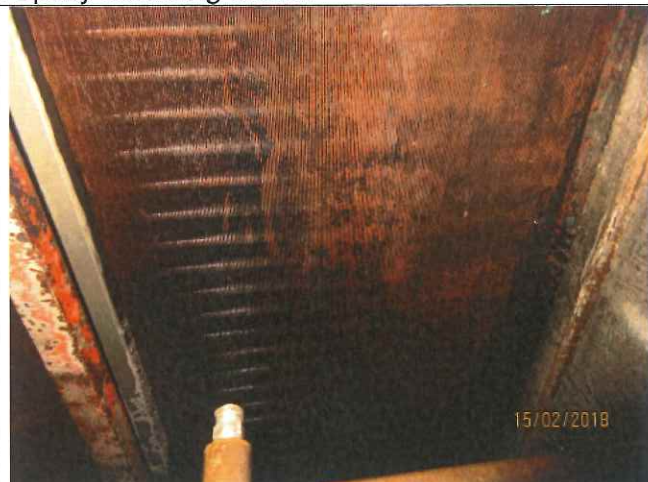
Inspection of the air cooler element, the element was acceptable condition but not sure the internal condition, carried out chemical and water spray cleaning done.

Air cooler element
