# MERCANTILE MARITIME SOLUTIONS PTE LTD

## FUEL PUMP INSPECTION REPORT

JOB NO : 1604078 TYPE : KAWASAKI B&W 7S80MC-C  
 CUSTOMER : \_\_\_\_\_ DATE INSPECTION : 6/3/2016  
 VESSEL : \_\_\_\_\_ CUSTOMER W/O NO : 2090-E-16-804 (91022230)  
 PREPARE BY : Maung CUSTOMER REQUIRE :  Normal Time  
 DESCRIPTION : 7 nos M/E Fuel Pumps  Urgent Time  
 Remarks : \_\_\_\_\_

FUEL PUMP CALIBRATION / INSPECTION REPORT

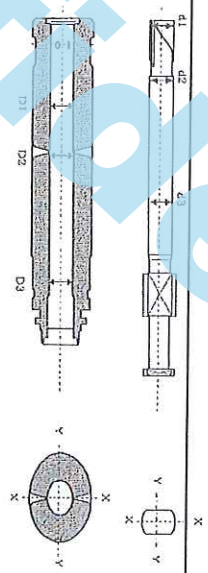
Remark : Total 7 nos plunger & barrel carried out inspection & calibration. Found No 4 Throttle plug missing

NOMINAL D/A : 90.0 mm  
 STANDARD CLEARANCE : 30 - 35 μ M  
 MAX. CLEARANCE LIMIT : 70 μ M

\* Max. Clearance limits for D1 & D2 area.  
 Plunger Mark - 3302537

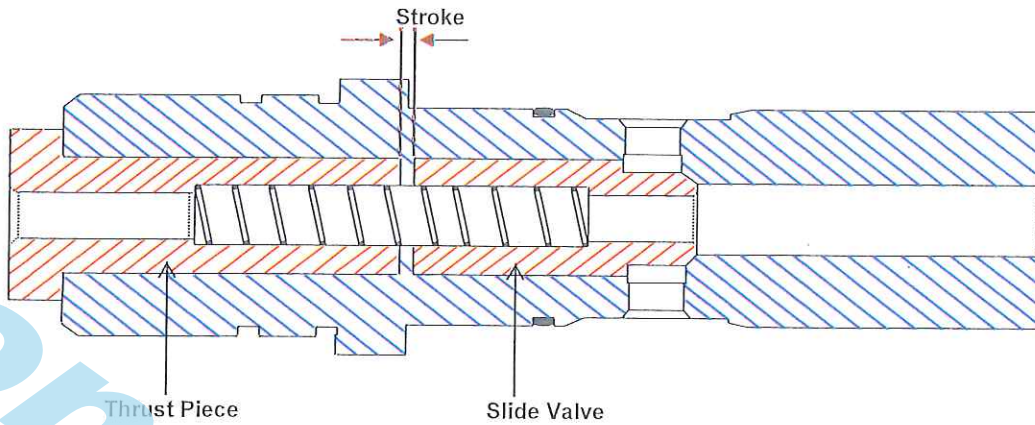
## Fuel Pump Suction Valve

Cylinder Unit	#1	#2	#3	#4	#5	#6	#7
Body No.							
Stroke	9.04	9.30	9.14	9.11	9.09	8.96	9.12
Remark
